# Experimental and analytical investigation of dynamic crack patterns in automotive windshield sheets subjected to low velocity impact

P. Shojaei Shahmirzadi, H. Saeidi Googarchin\*

Automotive Fluids and Structures Analysis Research Laboratory, School of Automotive Engineering, Iran University of Science and Technology, Tehran 16846-13114, Iran

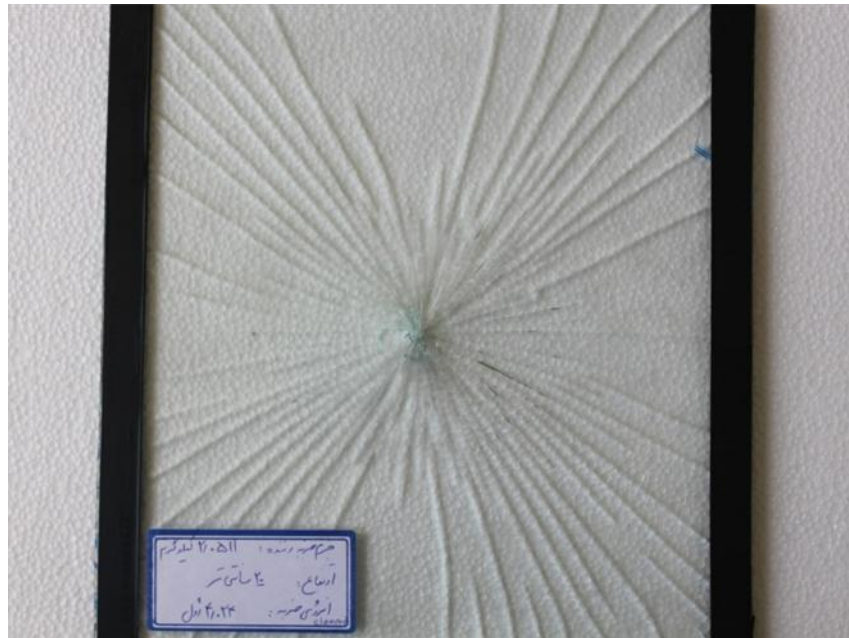
Laminated glass specimen after test code D-B-T-1 is shown in Fig. 4.

As it is observed from Fig. 4, the impact region at the center of specimen is a circle with approximate diameter of 3mm. Indeed, due to low energy of impact, the impactor has not caused remarkable damage at the impact area. In addition, the impactor has not penetrated in the specimen and damage is superficial. As a matter of fact, the impact energy has been released through radial cracks propagation and the impactor has not had any penetration in the specimen.

It can be inferred from Fig. 4 that the radial cracks in test code D-B-T-1 are nearly symmetrical and about 67 from which this quantity, 60 cracks have been extended to the borders of specimen and released their energy

through reaching the border of specimen. As a consequence, the damage mode is dynamic crack propagation. In this specimen, no circumferential crack is observed which can be due to low level of impact energy. Consequently, it seems that although all the impact procedure occurs in less than some milliseconds, radial cracks are made at the first stage. At the vicinity of impact region, some sectors of circles are observed which are distributed sporadically to the approximate radius of 6mm from the center of specimen. Moreover it can be seen from Fig. 4 that the radial cracks have been propagated from the impact surface of laminated glass. On the other hand, the radial cracks in this specimen are superficial and have not reached the lower surface of specimen, hence it can be understood that the fracture of laminated glass begins with superficial cracks at the upper surface of specimen.

Fig4..specimen after test code D-B-T-1
