Experimental and analytical investigation of dynamic crack patterns in automotive windshield sheets subjected to low velocity impact

P. Shojaei Shahmirzadi, H. Saeidi Googarchin*

Automotive Fluids and Structures Analysis Research Laboratory, School of Automotive Engineering, Iran University of Science and Technology, Tehran 16846-13114, Iran

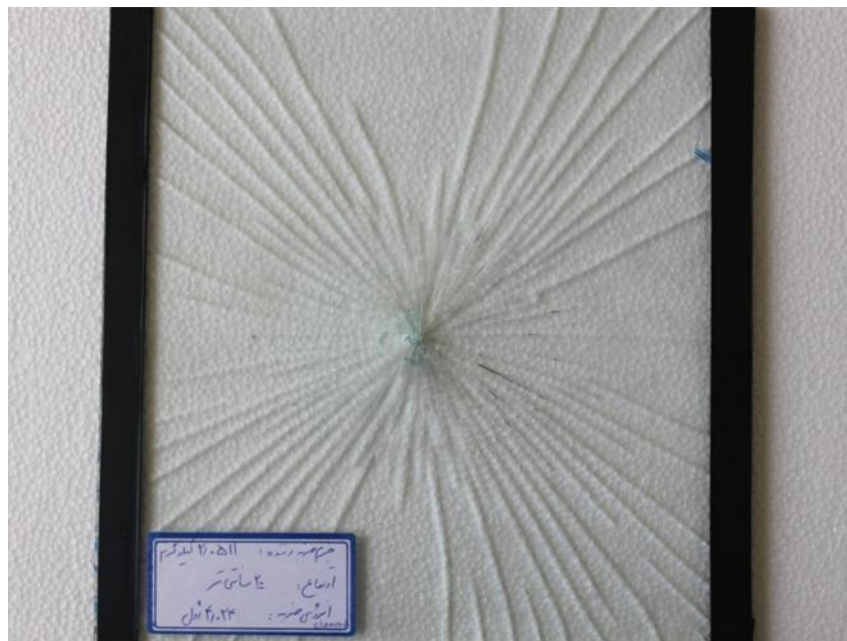
Laminated glass specimen after test code D-B-T-1 is shown in Fig. 4.

As it is observed from Fig. 4, the impact region at the center of specimen is a circle with approximate diameter of 3mm. Indeed, due to low energy of impact, the impactor has not caused remarkable damage at the impact area. In addition, the impactor has not penetrated in the specimen and damage is superficial. As a matter of fact, the impact energy has been released through radial cracks propagation and the impactor has not had any penetration in the specimen.

It can be inferred from Fig. 4 that the radial cracks in test code D-B-T-1 are nearly symmetrical and about 67 from which this quantity, 60 cracks have been extended to the borders of specimen and released their energy

through reaching the border of specimen. As a consequence, the damage mode is dynamic crack propagation. In this specimen, no circumferential crack is observed which can be due to low level of impact energy. Consequently, it seems that although all the impact procedure occurs in less than some milliseconds, radial cracks are made at the first stage. At the vicinity of impact region, some sectors of circles are observed which are distributed sporadically to the approximate radius of 6mm from the center of specimen. Moreover it can be seen from Fig. 4 that the radial cracks have been propagated from the impact surface of laminated glass. On the other hand, the radial cracks in this specimen are superficial and have not reached the lower surface of specimen, hence it can be understood that the fracture of laminated glass begins with superficial cracks at the upper surface of specimen.

Fig4..specimen after test code D-B-T-1

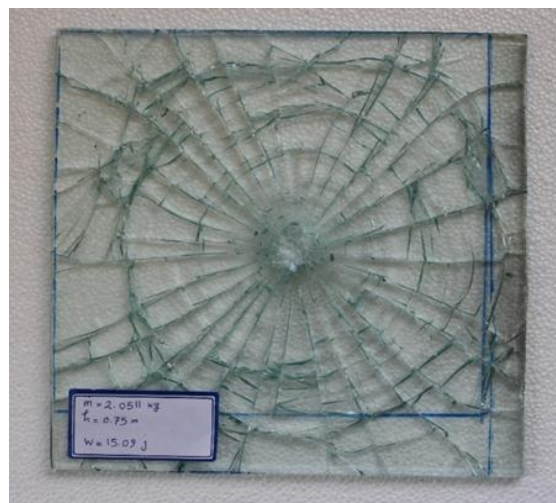
Laminated glass specimen after test code D-B-T-5 is shown in Fig.12.

Fig12. .specimen after test code D-B-T-5

As it is observed from Fig.12, the impact region at the center of specimen (powdering region) is a circle with approximate diameter of 20mm in which cracks density and consequently damage level is higher than the other regions of specimen. The projectile has penetrated to the depth of 4mm of the laminated glass, indeed the upper layer glass has fractured and PVB interlayer has elongated, but no tearing is observed. At the center of test code D-B-T-5 laminated glass, penetration depth has increased in comparison to test codes D-B-T-4 and D-B-T-3. Total number of circumferential cracks of the specimen is 5 which are placed at 47, 70, 80, 90 and 105mm distance from the center. At the vicinity of borders (close to clamping spots), net shaped diagonal cracks are more congested. Cracks have been propagated from the impact surface of laminated glass. At all 4 sides of the specimen, diagonal asymmetrical net shaped cracks have been made. At both upper and lower glass layers, radial cracks converge at the center of the specimen and their divergence increases at larger radiuses. Most of radial cracks have reached the borders of specimen and released their internal impact energy by this way.

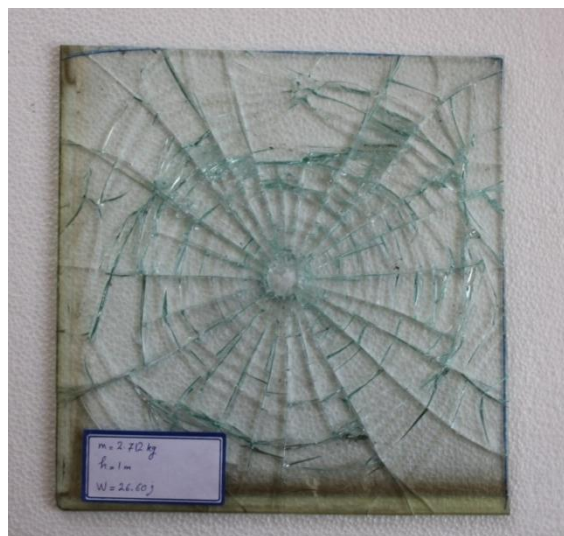
Fig14. .specimen after test code D-B-T-6

Laminated glass specimen after test code D-B-T-6 is shown in Fig.14.

As it is observed from Fig.14, the impact region at the center of specimen (powdering region) is a circle with approximate diameter of 20mm in which cracks density and consequently damage level is higher than the other regions of

specimen. In this test, the projectile has penetrated thoroughly in specimen. Therefore the glass layers have fractured and the PVB interlayer has torn. This test (test code D-B-T-6) has higher impact energy level in comparison to test code D-B-T-5. It can be observed that the penetration at the center of test code D-B-T-6 specimen is deeper than test code D-B-T-5, on the other hand the number of radial cracks is smaller in test code D-B-T-6. In fact, the impact energy has been released mostly through penetration in thickness direction and residual energy has released through radial and circumferential cracks. The radial cracks in test code D-B-T-6 are nearly symmetrical and about 24 which has decreased about 20% in comparison to test code D-B-T-5, but the penetration depth has

increased about 50%. It shows that approximate 76% increase in impact energy level in test code D-B-T-6 in comparison to test code D-B-T-5, has been released mostly through increase in penetration depth and radial and circumferential cracks in further priorities.

There are 6 circumferential cracks in the specimen at the radiuses of 34,41,51,60, 70 and 95mm from the center of the laminated glass sample. It can be seen from Fig.14 that the radial cracks have been initiated from the impact surface of laminated glass and propagated along thickness direction. In one side of the laminated glass, sectors of circumferential cracks like grids, have connected radial cracks to each other. 12 out of total 24 radial cracks have extended to the borders of the specimen and released their internal impact energy by this way. The acceleration versus time graph of test code D-B-T-6 is illustrated in Fig.15
