Experimental and analytical investigation of dynamic crack patterns in automotive windshield sheets subjected to low velocity impact

Abstract

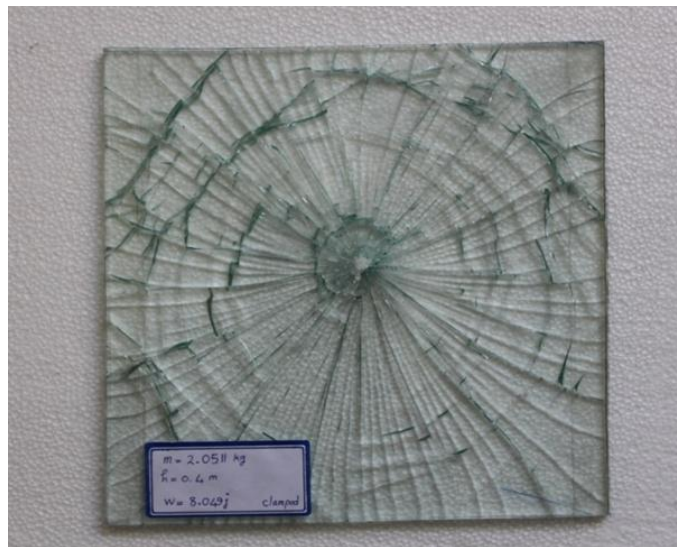
Fig10. .specimen after test code D-B-T-4

Laminated glass specimen after test code D-B-T-4 is shown in Fig.10.

As it is observed from Fig.10, the impact region at the center of specimen (powdering region) is a circle with approximate diameter of 20mm in which cracks density and consequently damage level is higher than the other regions of specimen. The projectile has penetrated to the depth of 1-1.5mm of the laminated glass and due to 2.5mm thickness of glass layers, no elongation has been occurred in PVB interlayer. Although energy level of test code D-B-T-4 is higher than test code D-B-T-3's one, penetration at the center of specimen is less in test code D-B-T-4 which

can be representative of impactor's mass influence. In test code D-B-T-4, the impactor mass is 2.0511kg, while it is 2.0712kg in test code D-B-T-3, therefore it can be concluded that in 2 similar conditions, the less impactor mass, the less penetration depth at the center of specimen.

It is easily seen from test code D-B-T-4 specimen that cracks have initiated from the impact surface and propagated through thickness. In this test, one circumferential crack has been propagated which is at the radius of 95mm from the center. Besides, some sectors of circumferential cracks have been made at the

radiuses of 62, 70 and 80mm from the center of specimen and serve as bridges to connect radial cracks. Also it can be seen from the laminated glass that the radial cracks in test code D-B-T-4 are nearly symmetrical and about 84. After drawing a comparison between test code D-B-T-4 and test code D-B-T-3, it is obvious that radial cracks of test code D-B-T-4 are more than their counterparts in test code test code D-B-T-3, on the other hand circumferential cracks of test code D-B-T-3 are more than test code D-B-T-3's ones. At test code D-B-T-4, distance between radial cracks is shorter than its corresponding item in test code D-B-T-3.

At all 4 sides of specimen which was clamped during the test, diagonal asymmetrical

net shaped cracks have been made which have created some right triangles in margins of the specimen. Diagonal net shaped cracks at the margins of test code D-B-T-4 specimen are more congested in comparison to the whole radial cracks. In addition, at both upper and lower glass layers, radial cracks converge at the center of the specimen and their divergence increases at larger radiuses. The acceleration versus time graph of test code D-B-T-3 is illustrated in Fig.11. As it can be seen from the graph, the maximum acceleration imposed to projectile is 732.0356m/s^2 which is occurred at 0.000131s .
