# INFLUENCE OF HEAT TREATMENT PARAMETERS, TEMPERATURE AND TIME, ON WEAR AND MICROHARDNESS OF NICRBSI FLAME SPRAYED COATINGS APPLIED ON CK45 SUBSTRATES

H. Arabi<sup>1,2 \*</sup>, S. Rastegari<sup>2</sup>, V. Ramezani<sup>2</sup> and Z. Valefi<sup>3</sup>

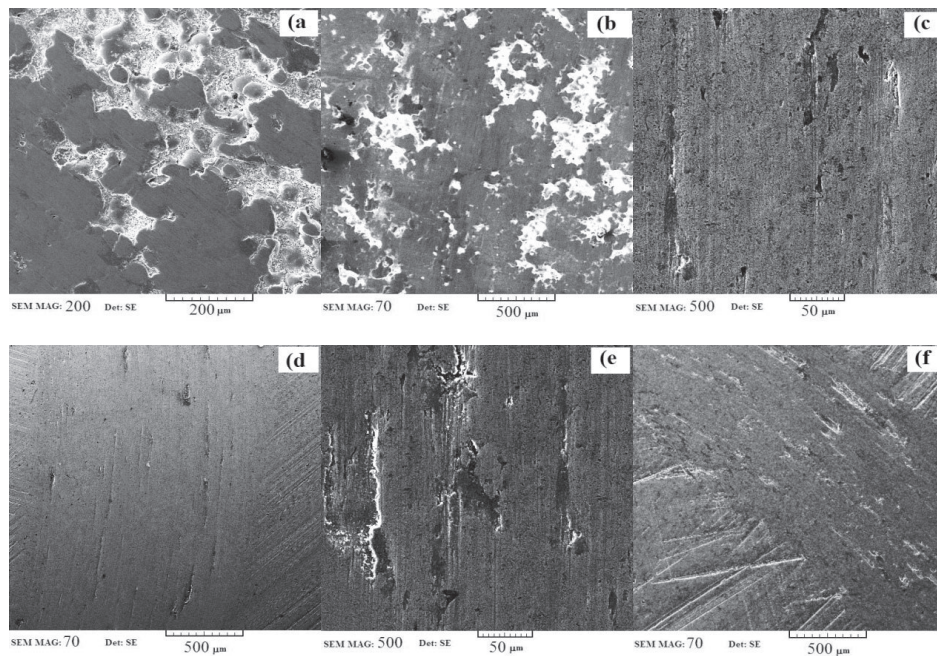
**Fig. 2.** SEM micrographs of worn surfaces of (a) and (b) 00-S-5, (c) and (d) 75-S-5, (e) and (f) 75-S-15 samples

samples are presented in Fig. 2 and their corresponding debris of these worn surfaces in Fig. 3. Fig. 3 shows the debris obtained from the sample 00-S-5 are large and have platelet morphology, while those obtained from sample 50-S-5 are smaller and have both polygonal and platelet shapes. The debris obtained from 75-S-5 and 75-S-15 samples were polygonal, however the mean size of 75-S-5 sample's debris was smaller than that obtained from 75-S-15 sample. In

addition, some of the worn areas on sample 00-S-5 contain very wide and deep grooves and it seems that they were formed due to pull out of the coating splats from the coated surface, while the grooves observed in 75-S-5 and 75-S-15 samples are mainly parallel scratches rather than pull out of splats.

Considering the topography of the worn surface of 00-S-5 sample (Fig. 2a and b), one can observe the splats were pulled out from the

coating surface due to weak cohesive force between the splats. The pull out of the splats during wear test of this type of coating seems to be due to fatigue wear as reported in a similar research by Miguel et al [9]. This mechanism was the dominate wear mechanism in the 00-S-5 sample. On the other hand, the dominate wear mechanism of the sample 75-S-5 seems to be abrasive wear as the parallel scratches observed on the worn surface can be an indication of abrasive wear (Fig. 2c and d). Over the worn coating surface of the sample 75-S-15 parallel scratches can be observed and it seems abrasive wear mechanism was also dominant in this sample.

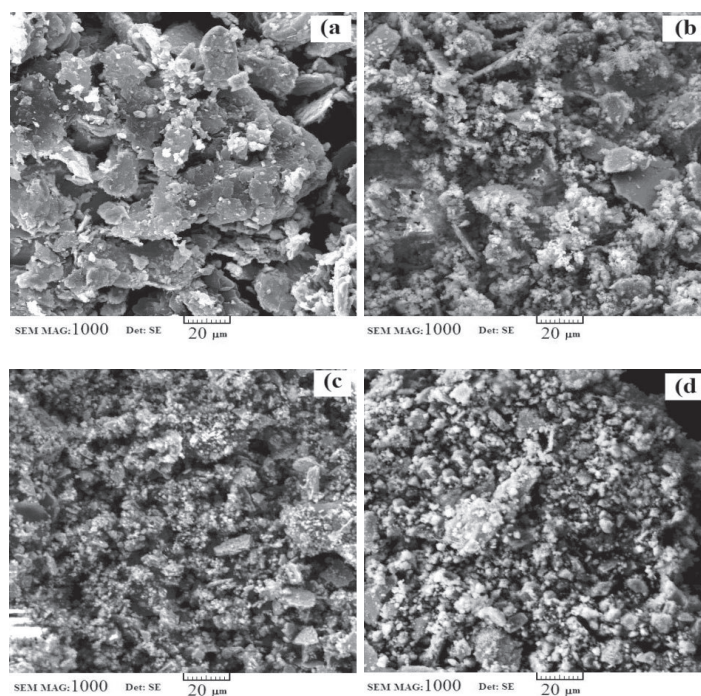
**Fig. 3.** SEM micrographs of the debris obtained from (a) 00-S-5, (b) 50-S-5, (c) 75-S-5 and (d) 75-S-15 samples

The mean size of precipitates in 75-S-5 and 75-S-15 samples were 1.2 μm and 3.4 μm respectively. Looking at the debris sizes obtained from the worn surface (Fig. 2) and compare them with the sizes of precipitates observed in the cross section of these coatings (Fig. 4), one may justifies the differences observed in the debris sizes obtained from the worn coatings. The bigger debris produced from 75-S-15 sample is actually due to larger sizes of precipitates existed

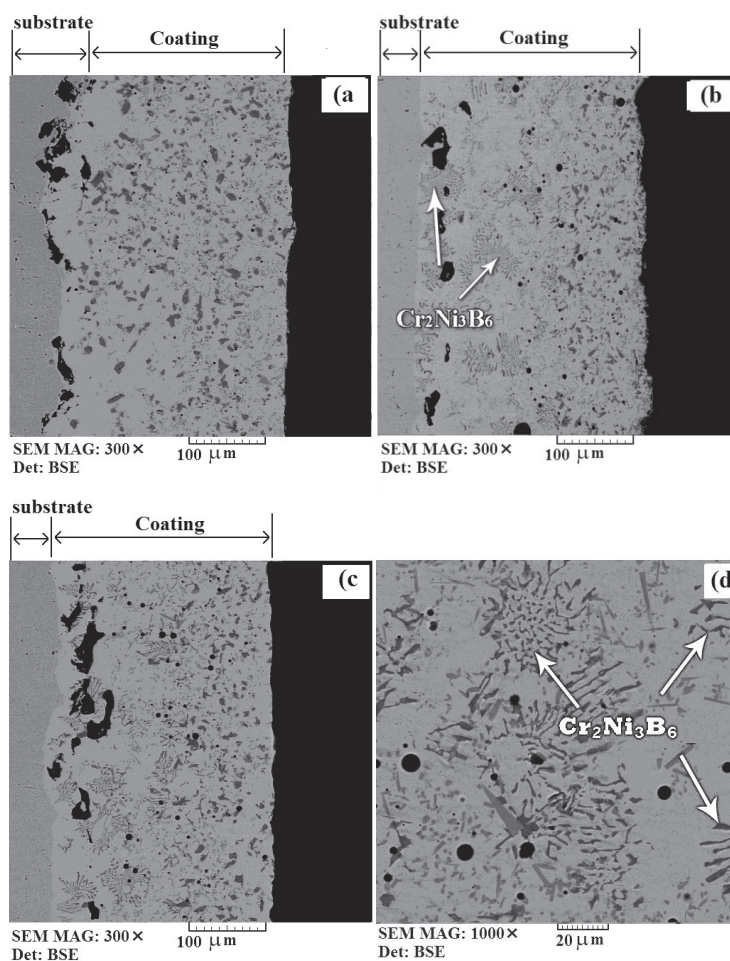
**Fig. 5.** SEM micrographs of cross section of (a) 75-S-15, (b) 100-S-10, (c) 100-S-15 and (d) 100-S-10 at higher magnification than Fig.4

precipitates were identified as CrB,  $(\text{Cr,Fe})_7\text{C}_3$ ,  $\text{Ni}_5\text{Si}_2$  and  $\text{Ni}_3\text{B}$ . It should be mentioned that CrB and  $(\text{Cr, Fe})_7\text{C}_3$  were identified by EDS analysis, while  $\text{Ni}_5\text{Si}_2$  and  $\text{Ni}_3\text{B}$  could not be characterized by EDS due to the negligible difference exit between their atomic weight and coating matrix (i.e. Ni), therefore they were identified by XRD analysis. Within the microstructures of the samples treated at 1100 °C for 10 and 15 minute a new phase with a stoichiometric composition  $\text{Cr}_2\text{Ni}_3\text{B}_6$  was detected. This phase which was not observed within all other samples formed within the coating in the vicinity of the substrate of 100-S-10 and 100-S-15 samples, Fig. 5.

distance of 150  $\mu\text{m}$  from its interface from the substrate. This observation might be related to the formation of  $\text{Cr}_2\text{Ni}_3\text{B}_6$  precipitates in 100-S-15 sample that was mentioned in previous sections. The coating microstructure of this sample can be seen in Fig. 5.

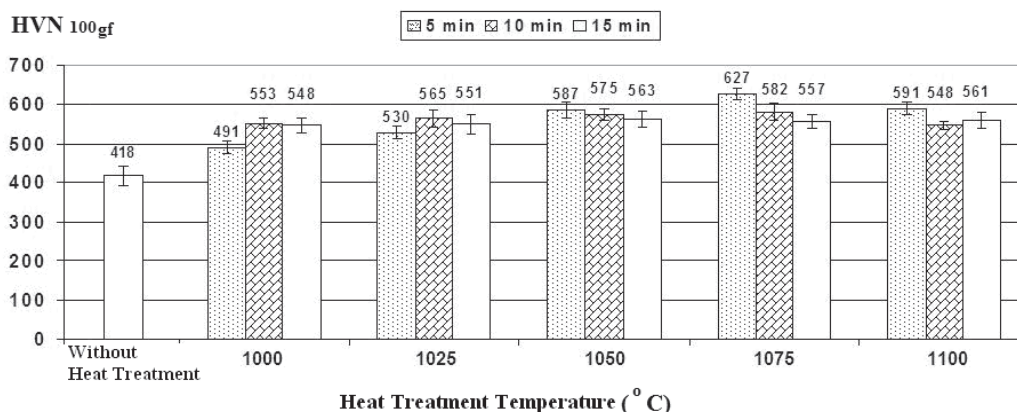
Fig. 8. The mean Microhardness values of coating surface of coatings treated at various temperatures and times

A comparison between the mean microhardness values of the coating surfaces is illustrated in Fig. 8. This figure shows the untreated coating surface has the minimum hardness, while the maximum hardness obtained at the surface of the coating treated at 1075 °C for 5 minute. The reasons for this behaviour were discussed earlier.
