FATIGUE BEHAVIOUR OF A ROLLED AZ31 MAGNESIUM ALLOYS PREPARED BY EP AND BB CONDITIONS

Abstract: Rotating bending fatigue tests have been performed using smooth specimens of a rolled AZ31 magnesium alloy in laboratory air at ambient temperature. Fatigue strength and characteristic was evaluated and fracture mechanism was discussed on the basis fracture surface analysis. Electrical polishing (EP) as well as deep rolling (ball burnishing (BB)) U-notched specimens were performed on two groups of samples, to evaluate optimum conditions for fatigue life. The microstructure and tensile properties of roll cast (RC) Mg- 3% Al- 1% Zn (AZ31) was investigated. The fatigue strength of 107 cycles around 100 MPa for deep rolling while it was around 40 MPa for Electrical polishing. It was very important to understand the effect of (ball burnishing (BB)) conditions on the hardness of the surface through to the core. The two procedures improved the fatigue performance, but better improve in results were found in ball burnishing. The growth of small cracks initiated at the surface coincided with the FCP characteristic after allowing for crack closure for large cracks, but the operative fracture mecha

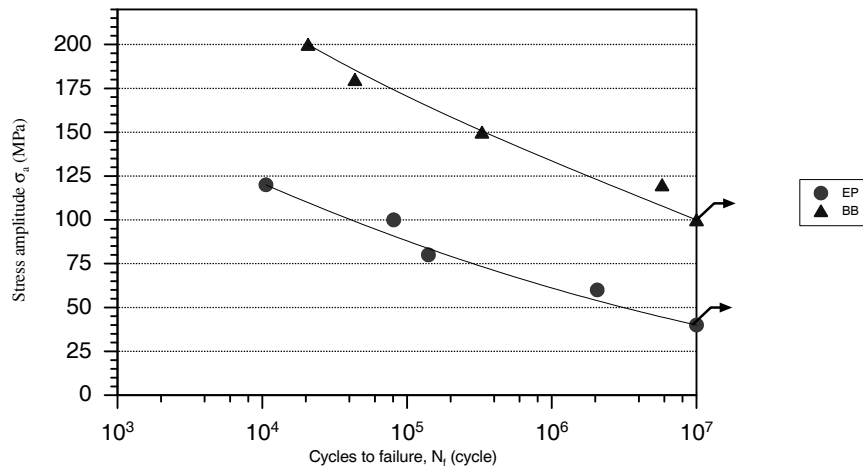
S/N curves for the EP and the BB specimens in laboratory at a stress ratio of -1 and frequency of 50 Hz (rolled magnesium alloy) in laboratory air is shown in Fig. 2. In this figure, for comparison purposes, the S–N curves of the EP and BB specimens are shown respectively. As seen from the figure, the fatigue life of the rolled magnesium alloy of EP specimen is relatively shorter than that of BB specimen. The extent bending in the S–N curve is gentler in the BB specimens than in the EP specimen. Next let us compare the S–N characteristics of the EP and BB specimens. There are great differences in the fatigue lives and in the fatigue limits, especially at higher stress amplitudes, there are differences in the fatigue lives.

Fig.2. S-N curve for rolled AZ31 at EP,BB conditions, rotating beam, R=-1, 50Hz.

4. Subsurface crack initiation occurred at applied stresses at 60 MPa. At BB condition but it can be seen for both 80 and 100 MPa stress for EP condition. The S-N diagram is shown in Fig. 2. It is well known that fatigue limit does not exist in non-ferrous alloys, thus fatigue tests were continued until 10^7 cycles. At EP condition $\sigma = 40$ MPa, fatigue failure did not occur, but non-propagating cracks were observed on the specimen surface. As can be seen in the figure, the present Mg alloy seems to possess a definite fatigue limit, which may be related to the existence of non-propagating cracks. The fracture mode depending

1. Fatigue strength at 10^7 cycles was 100 MPa

for BB condition with the following preparation condition on ECOROLL instrument using tool type (HG6) at 100 bar (246 N) with feed rate of 0.17 mm/min at 30 rpm. While the fatigue strength at 107 cycles was 40 MPa for EP condition.

2. Fatigue lives and the fatigue limit of BB specimens were higher than those of EP specimens with similar profiles.
3. Electrical polishing and ball burnishing preparation are very sensitive to working procedure of choosing temperature for EP or in choosing (Feed, Speed and tool head) for BB condition. After many trails to find out the good combination of the three parameters.
4. As a result of crack initiate from the surface for EP condition it fails under lower stress than in BB condition which crack initiate internally (as surface treated by BB).
5. It could be investigate the best condition of BB by examine the surface up to 500 μ m for microhardness value, to choice best values for BB treatment.

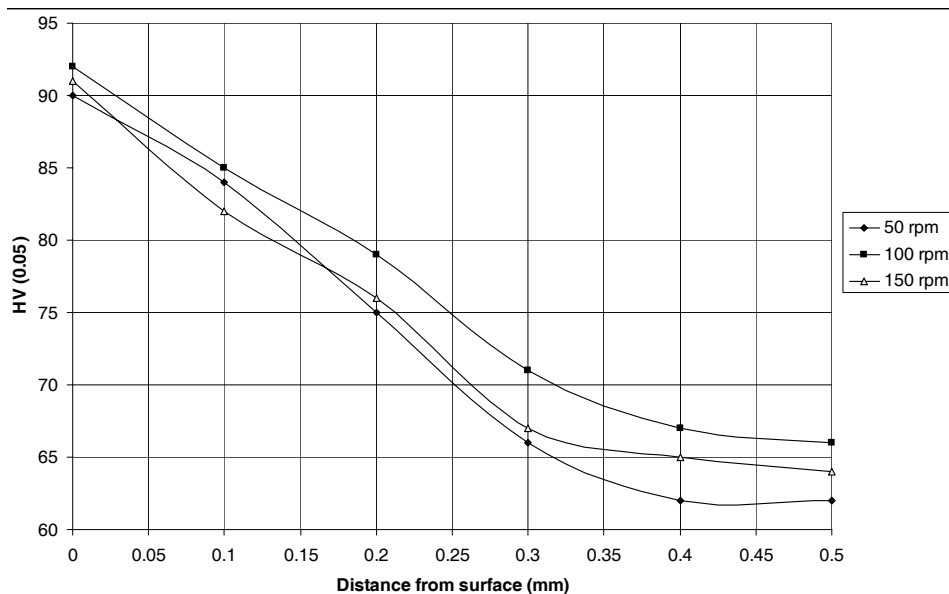
3. 3. A different experiment were used to investigate the best condition for BB (pressure, feed rate, speed) as example for tool HG3 200 bar (123 N) for 50, 100 and 150 rpm. The microhardness measurement from the surface in Fig. 3. Shows that the suitable condition for using 200 bars is 100 rpm for AZ31 as the hardness decreased from the circumference gradually to the center.

Fig. 3. Microhardness profile of AZ31 after BB at 200 bars, 0.17 mm/min at different BB rotation speed.

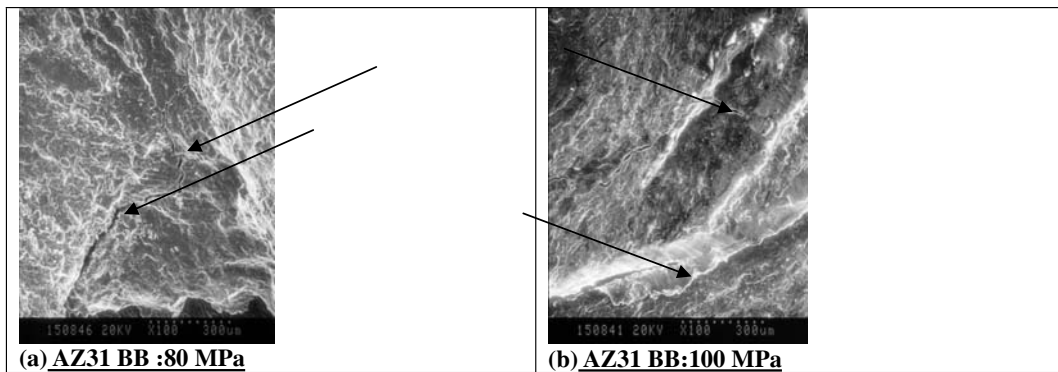
Fig. 5. SEM micrographs showing cracked surfaces at difference stress for BB at (a) 80MPa; (b) 100 MPa

The cracked line could be seen easily for higher stress for BB condition as fracture occurs in internal surface not at the outer surface as in the EP condition in Fig. 5.
